KCE STRUCTURAL ENGINEERS, P.C.

August 30, 2013

RE: Westfield Montgomery Mall Westlake Garage
Gridlines 14 and 15 and C and D
Partial Precast Tee Collapse
Cause and Effect

Job No. 2013-10

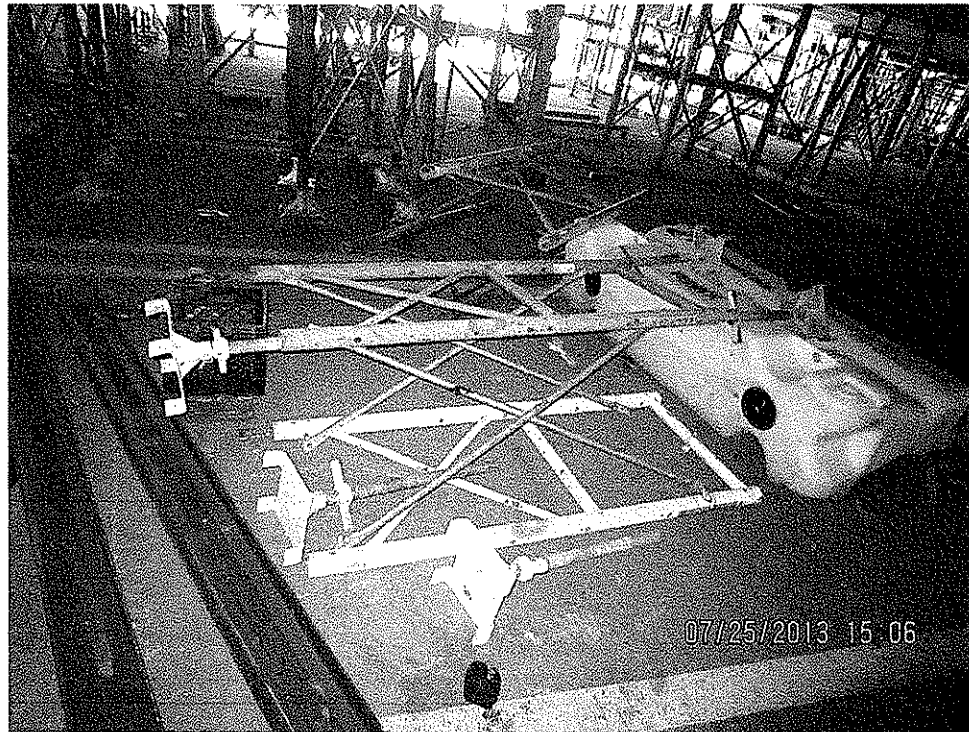
As can be seen in Pictures 1-3 below, the screw jacks were extended beyond 12" therefore reducing the capacity of the shoring towers. The extension shown in Picture 3 was measured to be a minimum of 16".

If 30 kips were applied to the transverse W8x31 directly in the center of the beam, distributing the load equally to each leg of the shoring tower, the reaction per leg of the frame would be 15 kips. The failure load of the AS25 base frame is 22 kips if the screw jacks are extended 16". Therefore, this scenario alone should not result in failure of the tower.

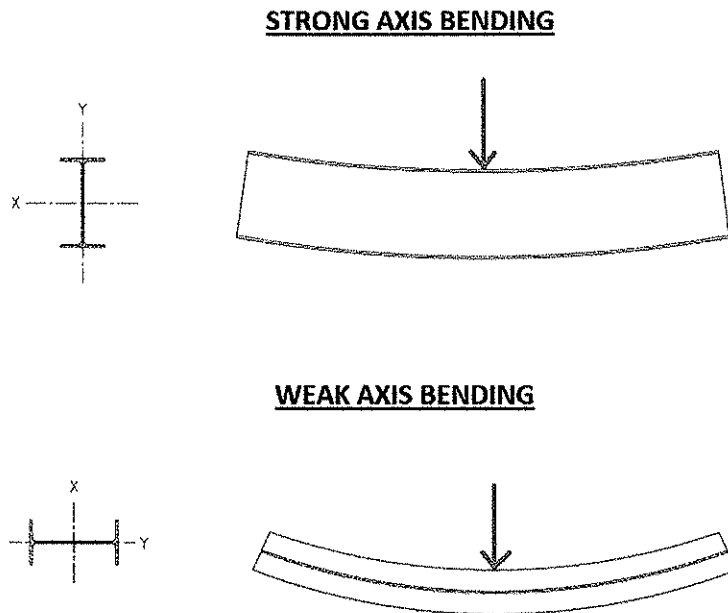
Figure 6- Diagram of Strong and Weak Axis Beam Bending

In the configuration shown on WT drawings J1-J5 the W8x10 and W8x31 beams on the "safety" and "jacking" towers have adequate strength to support the load of the precast double tee even if the entire load is concentrated in one location on the beam. This is true as long as the load is applied to the strong axis (Figure 6). As can be seen in Picture 4, where the longitudinal beam rotated, apparently during the collapse, bending will occur when load is applied to the weak axis (Figure 6).
